Waterwatch Water Quality Site Summary Report for 2018

Site Name & Description: ME_YMR 119 Merri Creek at Northcote Golf Club, Brunswick East

Monitors: Merri Creek at Northcote/Brunswick East WW group

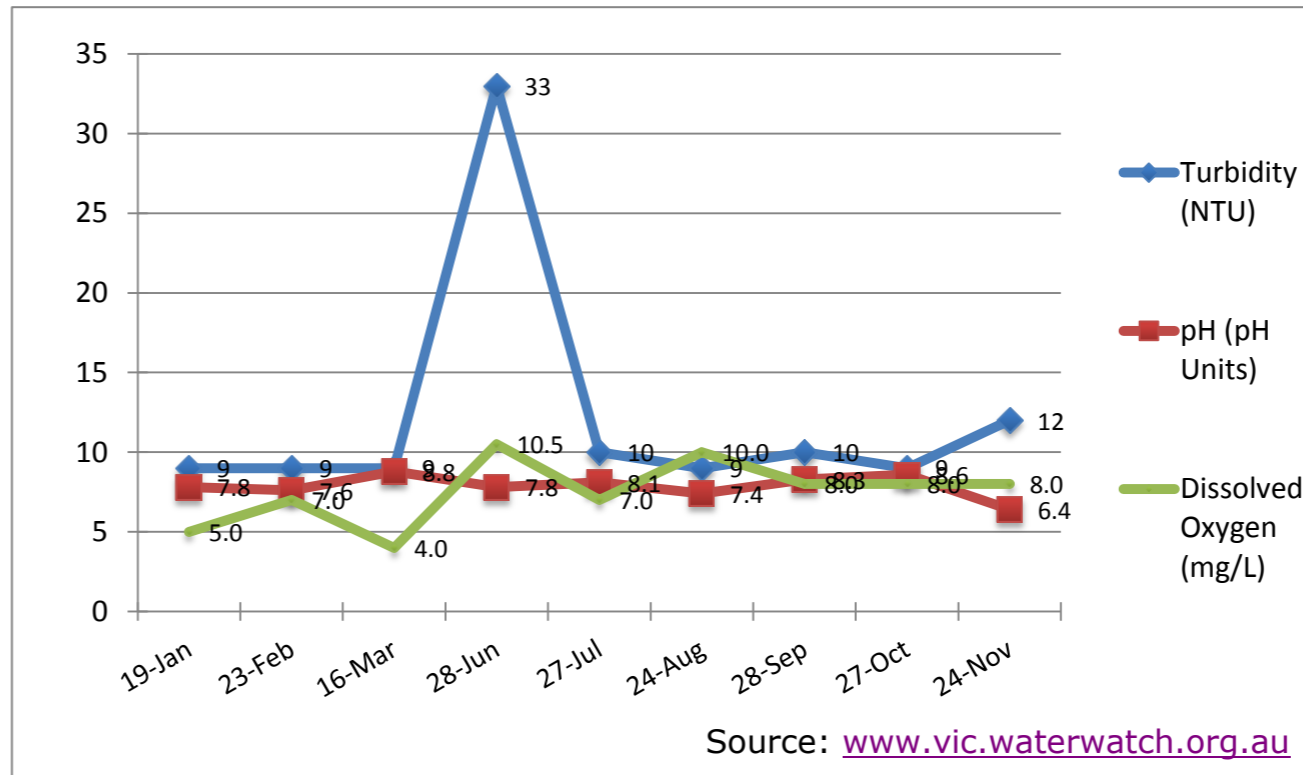
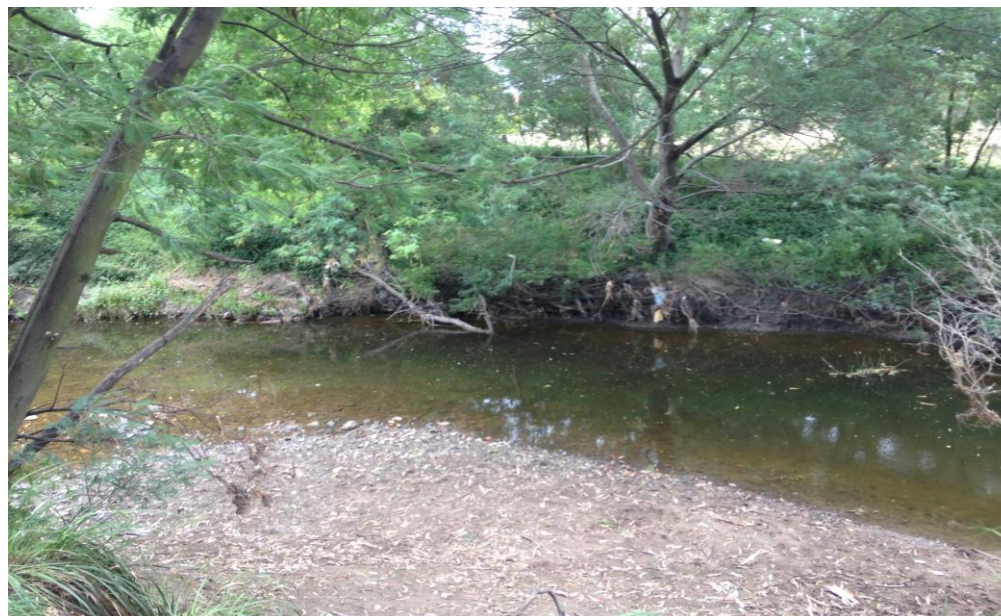
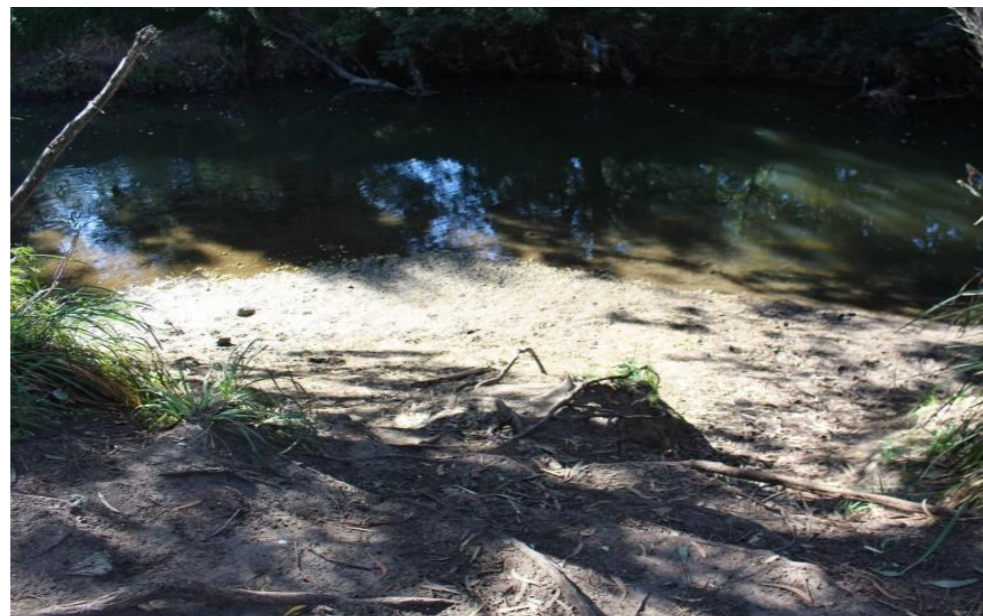
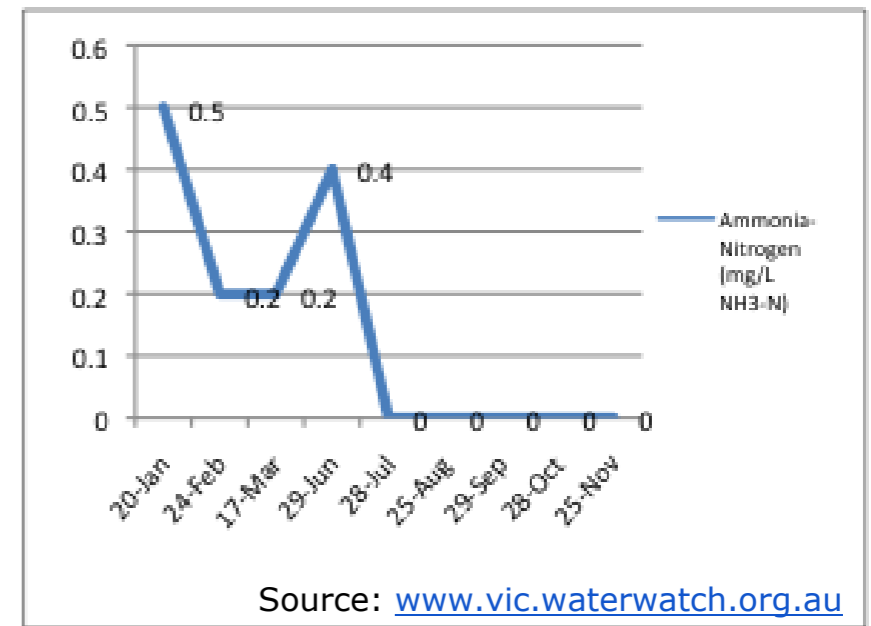
Dissolved oxygen levels were consistent throughout the second two thirds of the year, despite starting low at the beginning of year (2018). The pH levels were also fairly consistent.

Turbidity was unusually high in June. Heavy rain, particularly upstream, may have contributed to the spike in this reading.

There were significant spikes for ammonia in the months of January and June (below).
