## 2018 Waterwatch Water Quality Site Summary Report

ME\_YFM980 5 Mile Creek, Upstream of Moonee Ponds Creek Confluence, Essendon.

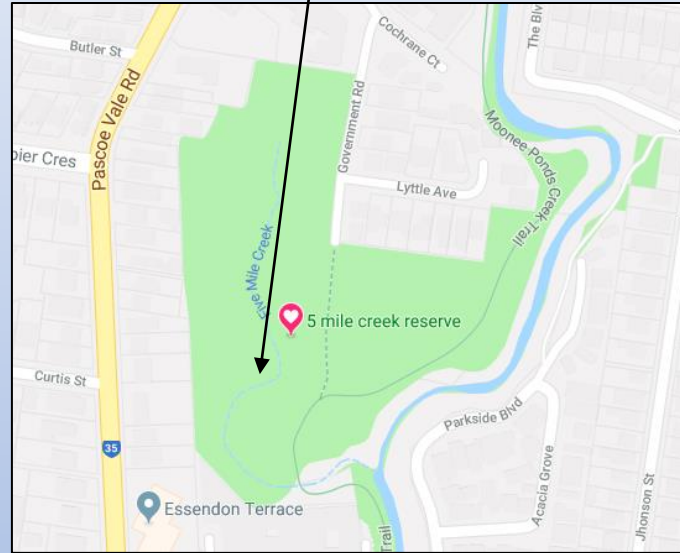
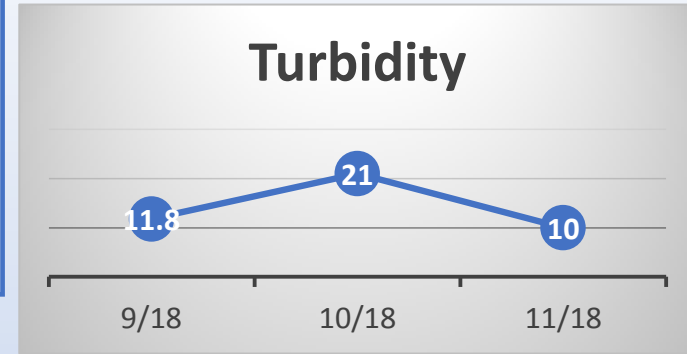
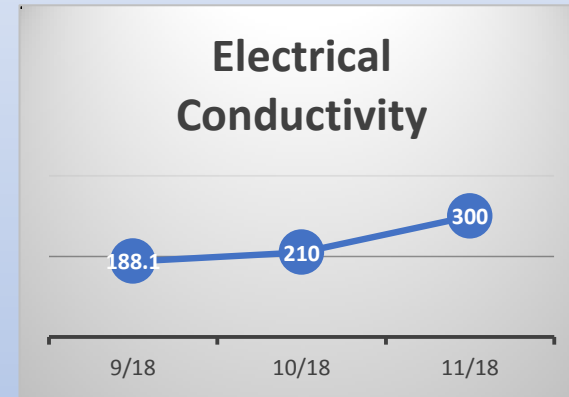
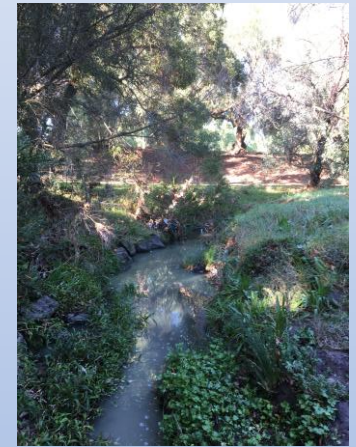
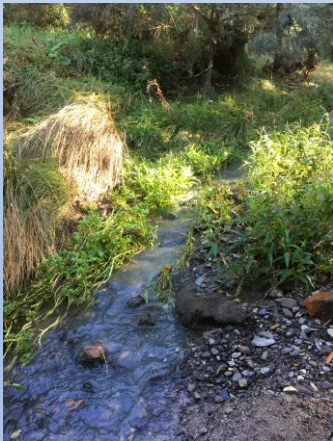
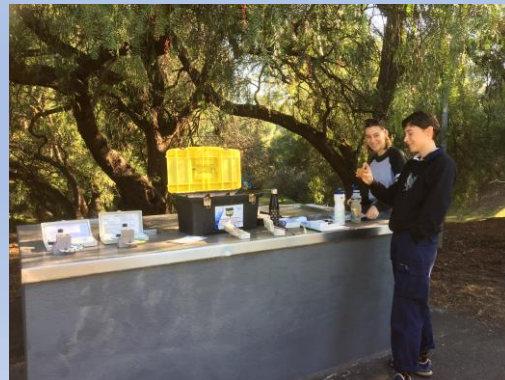
**Summary:** Over three sampling sessions in 2018 pH, phosphate, and oxygen levels were relatively stable and not indicative of severe degradation – surprising given this is a storm water drain.

In October we recorded a spike in turbidity (21 NTU), and electrical conductivity peaked at 300 uS/cm in November.
