Waterbug Report: Merri Creek upstream of St. Georges Rd Bridge, Nth Fitzroy

Site Code: ME_YMR112

DATE: 6/2/2022

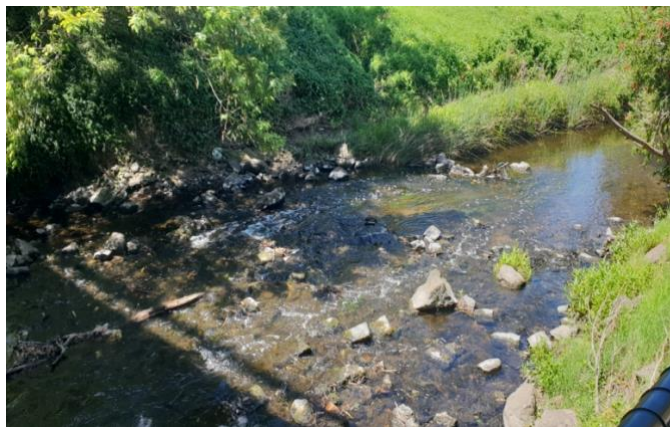
The sampling site on the Merri Creek consists of an area 50 metres north of the St. Georges Rd bridge and stretching back under the bridge to about 30m south of it. North of the bridge the creek bottom consists many of large basalt boulders and the sampling is along the edge vegetation although, at times of low stream flow much of this is about the water level. Immediately under the bridge and south of it is an area of riffles consisting of a mixture of large and small basalt rocks along with mixed rubble of human origin. Further south the stream contains a mixture of in stream and edge vegetation and some woody debris. Samples are taken from all of these macro habitats.

The weather was sunny and there had been rain in the preceding week. The creek appeared stained brown and the level low, with continuous flow in the channel and instream habitats connected.
