ME_YED070 Edgars Creek, upstream of Edwardes Lake, next to Reservoir Scout Hall, Leamington Street, Reservoir. 2018 Waterwatch Water Quality Summary Report.
Monitor: Kyle O'Farrell and the Reservoir Frogs

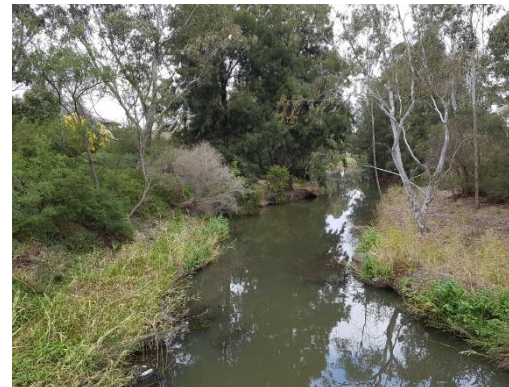
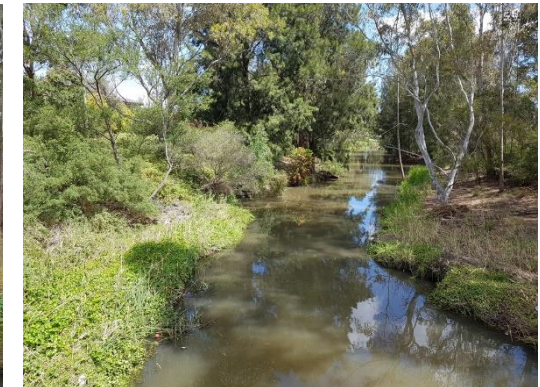
Phosphate was consistently high at the Edgars Creek site during 2018. However, ammonia (chart not shown) was measured at 0 mg/L at each monitoring session.

The pH at the site was generally fair to good in quality.

The conductivity was of a poor to degraded level at each monitoring session.

The dissolved oxygen level was generally of a good to excellent level.
