Waterbug Report: Edgars Creek at the Waterfall, Ronald St., Coburg

ME_YED030

DATE: 6/2/2022

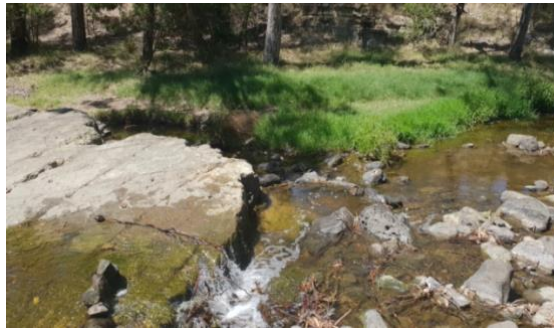
The sampling site on Edgars creek lies a few hundred metres upstream of its confluence with Merri creek. The site consists of a rock ledge with a pool approx. 1 m deep and 10 m across upstream and a downstream rocky riffle about 20m long and descending approx. 2 m in elevation. Below this the stream contains some edge vegetation and some woody debris. Some years ago, the upstream pool also contained good edge vegetation but most of this has been stripped away by erosion, The pool is frequently used by dog owners to allow their pets to swim. The weather was sunny and there had been rain in the preceding few days. The creek appeared clear and the level low with continuous flow of water connecting all stream habitats except over the rock ledge.
